23-July-2011

## O-ring tear when installing SMART-O in oil pans with heli-coil inserts

## Installing 'F1' plug in oil pans that use a helicoil insert may tear O-ring

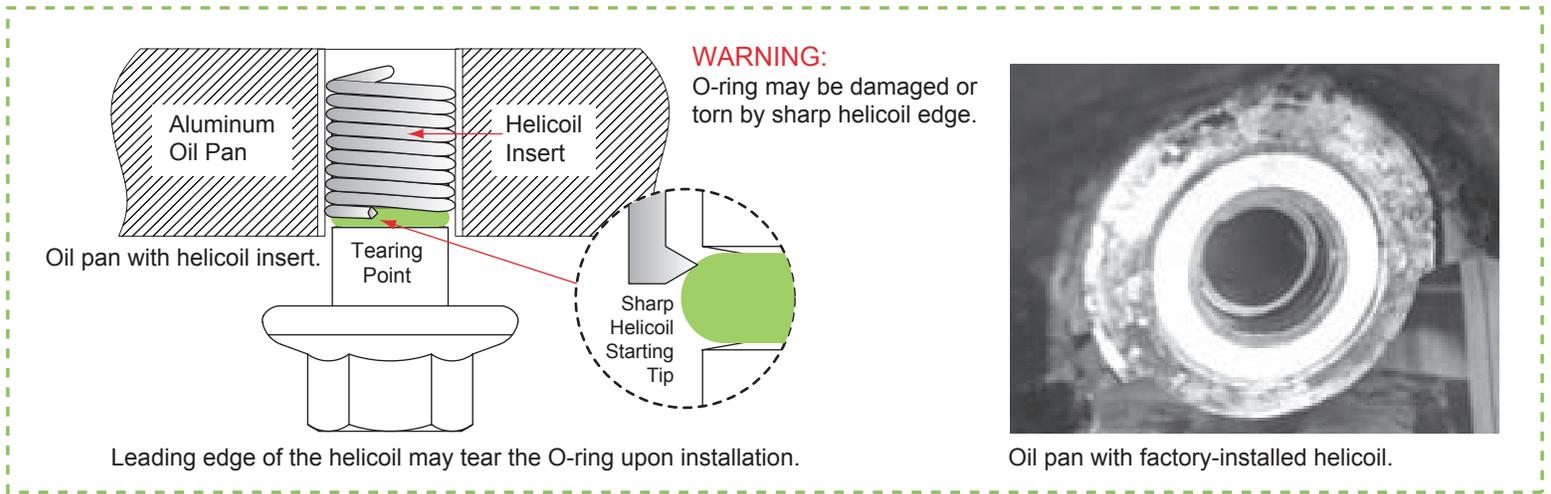
The affected vehicles will have an aluminum oil pan with a helicoil installed from the factory.

1. Carefully check the drain plug port of the oil pan and inspect if it has a helicoil insert. Initial testing is completed but will be part of a continuous process.
2. DO NOT INSTALL AN F-1 SMART-O PLUG, IF A HELICOIL IS PRESENT
3. Instead, inspect the OEM washer, then reinstall the OEM plug and torque to manufacturers' specifications

Install 'H1' SMART-O plug - an alternative for helicoil-insert oil pans.
